Improving Train Station Design

Pedestrian flows
train station Oerlikon

Ernst Basler
+ Partner AG

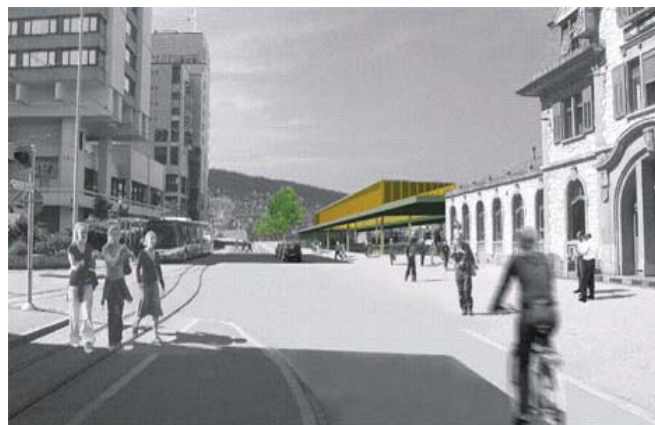
The simulation study compared two different train station upgrading scenarios: one called „underpass with platform connection“, the other „underpass without platform connection“. Software requirements for this case entailed pedestrians choosing routes

depending on available capacities, densities (bottlenecks) and number of pedestrians in the system. Additionally, the software had to allow modeling of stairs based on actual capacity. The simulation study with SimWalk showed the displacement of pedestrian flows, depending on the different upgrading scenarios of Oerlikon train station.

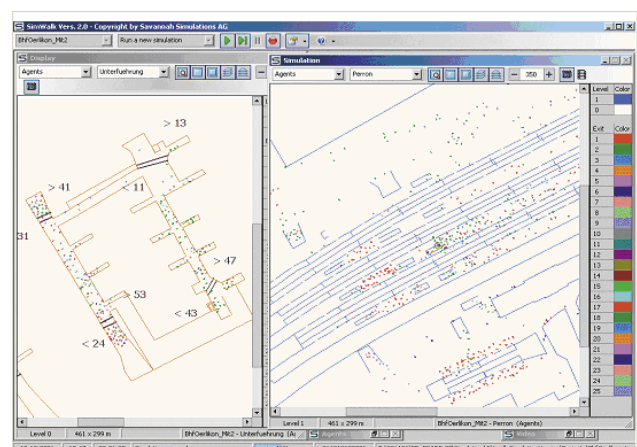
Further simulation results were, firstly, the discovery of capacity bottlenecks of platform stairs leading down to the underpass. Secondly, additional bottlenecks were discovered at the entrance stairs to the underpass, connecting train station forecourt and underpass.
